Manhole Inspection Summary

Manhole # S25K__004MH

Insp Date: 1/30/09 11:22 AM

Location Address: **201 S. Arlington**

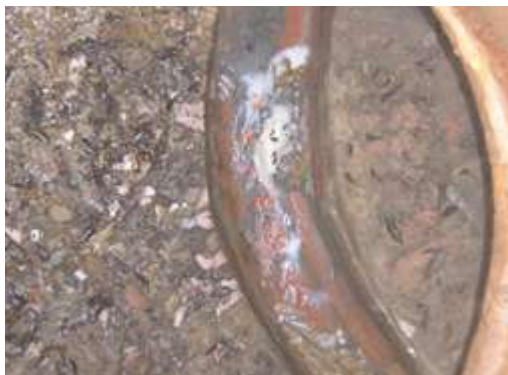
Misc

Condition: ☐ Sound ☐ Cracked ☐ Root Intrusion ☐ Deteriorated ☐ Leaks ☒ **Debris**

channel debris

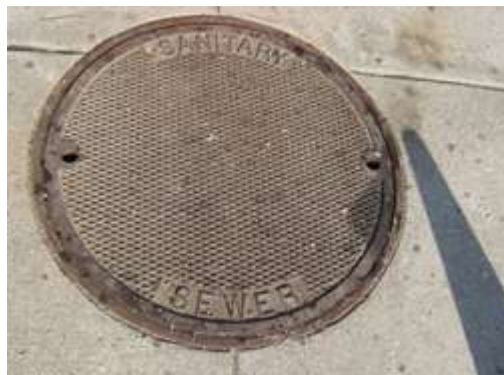
Misc

cover

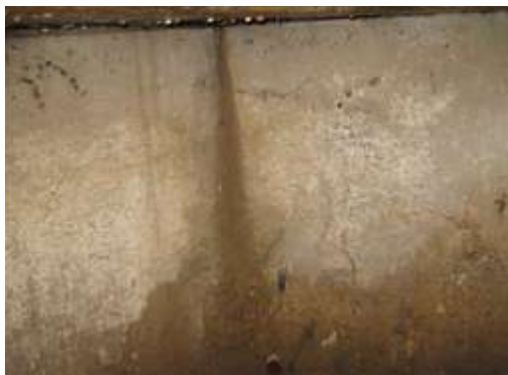
Defect 6

Infiltration: ☐ None ☒ **Joint** ☐ Cracks ☐ Mortar ☐ Roots ☒ **Wall**

corbel infiltration at chimney joint

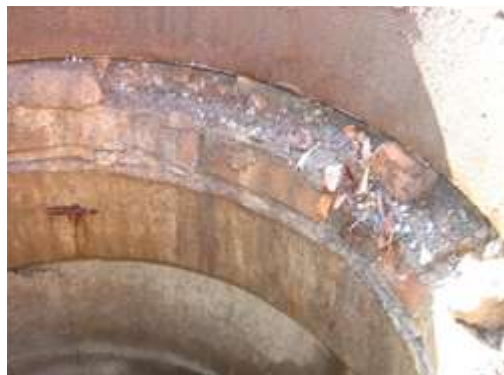
Defect 5

Frame Offset: **2** (in.) Condition: ☐ Sound ☐ Cracked ☒ **Leaks**

Condition: ☐ Sound ☐ Cracked ☐ Root Intrusion ☒ **Loose Brick** ☒ **Deteriorated**

frame influent at cover, chimney loose bricks and deteriorated

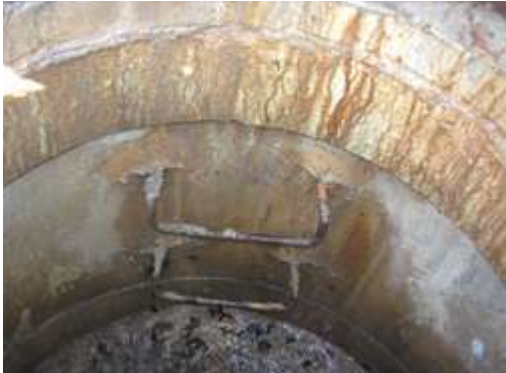
Defect 4

Infiltration: ☐ None ☒ **Joint** ☐ Cracks ☐ Mortar ☐ Roots ☒ **Wall**

chimney influent at frame joint and wall

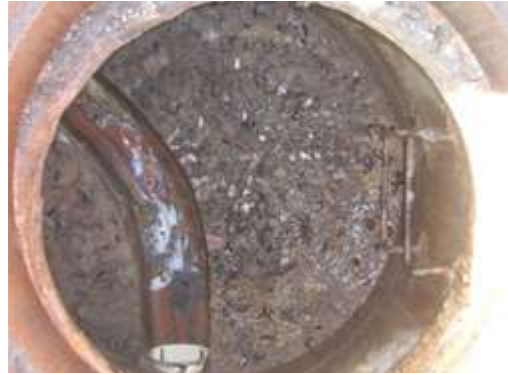
Defect 3

bench debris

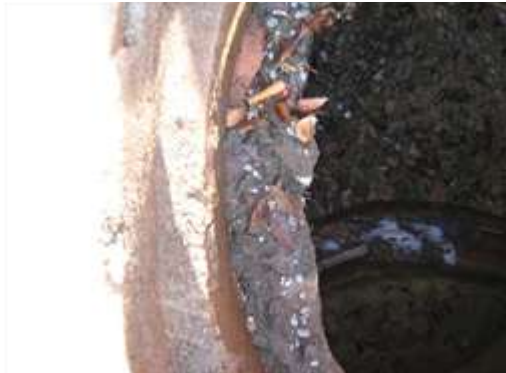
Defect 2

frame offset 2 inches

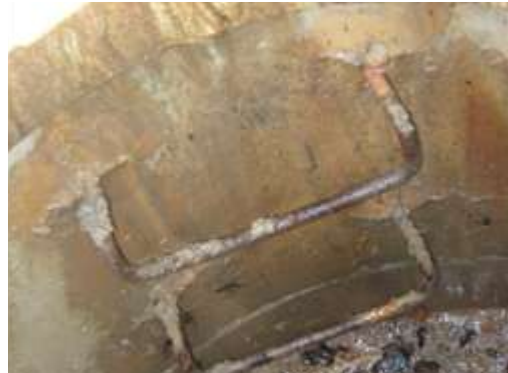
Defect 1

Steps Count: **2** Missing: **0** ☒ **Corroded**

steps corroded

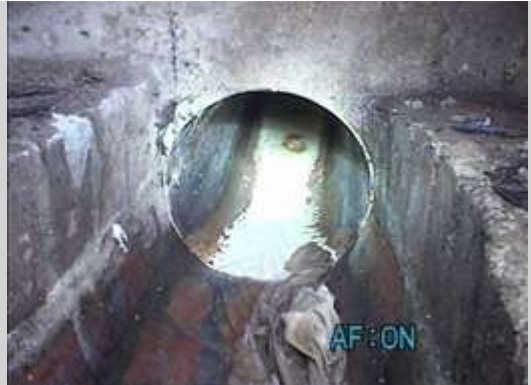
12 O'Clock Outflow

8 in. Circular Gravity Sewer
Pipe Out @ 12 O'Clock

Pipe Height: **8.4** (in.) Rod and Bar (Angled)
Pipe Material: **PVC** ☐ Pipe Lined
Invert Depth: **5.60** (ft.) Flow Characteristics: **Fast**
Deposits: ☒ None ☐ Mud ☐ Sludge ☐ Debris ☐ Grease
Silt Depth: **0** (in.) Deposits Extent:
Infiltration: **None** Pipe Seal Cond: **Sound**

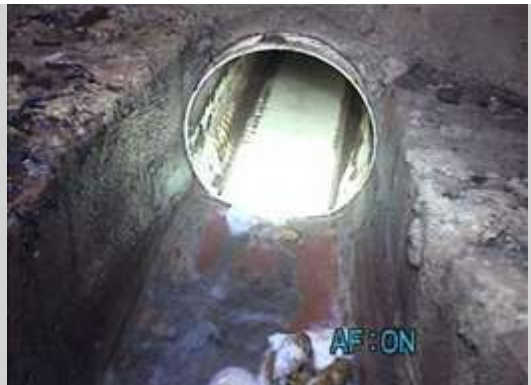
7 O'Clock Inflow

8 in. Circular Gravity Sewer
Pipe In @ 7 O'Clock

Pipe Height: **8.4** (in.) Rod and Bar (Angled)
Pipe Material: **PVC** ☐ Pipe Lined
Invert Depth: **5.53** (ft.) Flow Characteristics: **Fast**
Deposits: ☒ None ☐ Mud ☐ Sludge ☐ Debris ☐ Grease
Silt Depth: **0** (in.) Deposits Extent:
Infiltration: **None** Pipe Seal Cond: **Sound**
